CASE STUDY

Vancouver Washington

Multi-Tenant Industrial Park

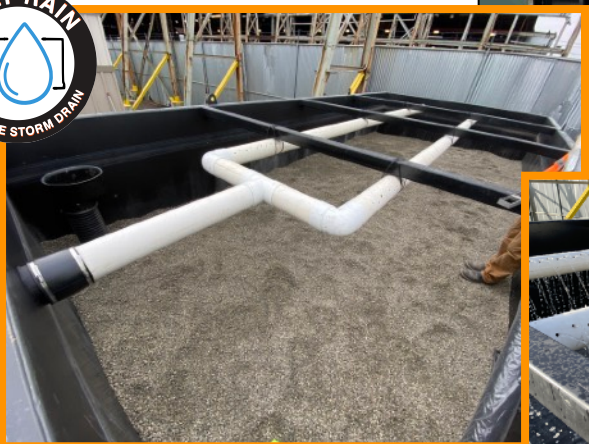
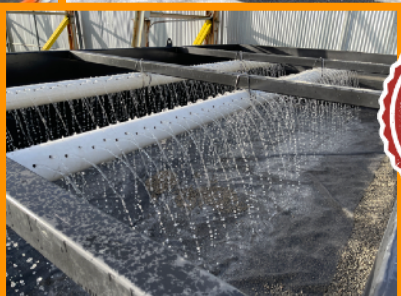
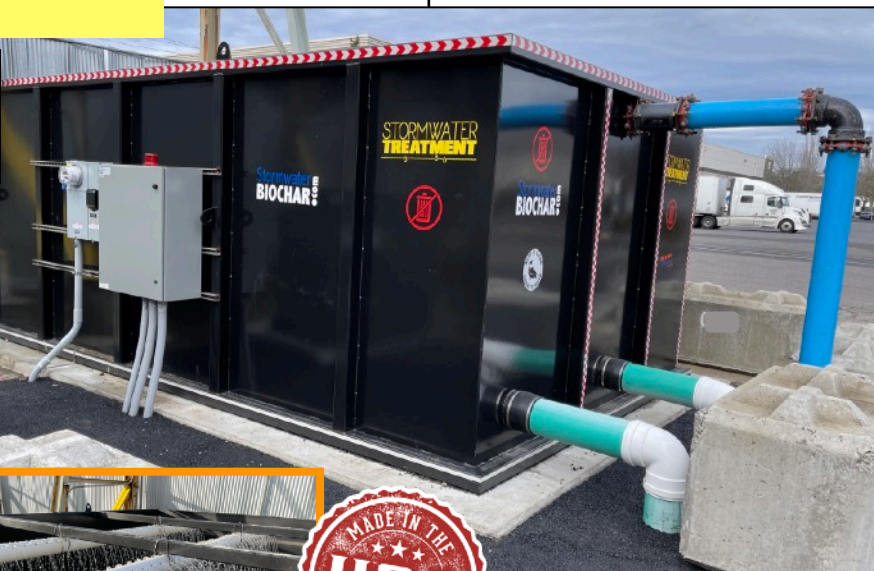
After evaluating proposals from three companies to treat the combined stormwater, the choice was to utilize **BiocharPEAT™** in a 350 GPM pump station with a 12' x 22' x 8' tall **CUSTOM TANK** built locally. The **CUSTOM TANK** includes 25 cubic yards of **BiocharPEAT™** treatment.

An existing catch basin had a weir added to it with a pipe on the influent side put into it to gravity feed the water to a new vault. In the vault, two 350 GPM pumps were installed to pump the water to the **CUSTOM TANK**. The stormwater then gravity flows through the **CUSTOM TANK** and back to the discharge side of the catch basin with the weir and leaves the site to the river.
