Case Study 2021

Los Angeles Area Testing Results

### **Automotive Parts Company**

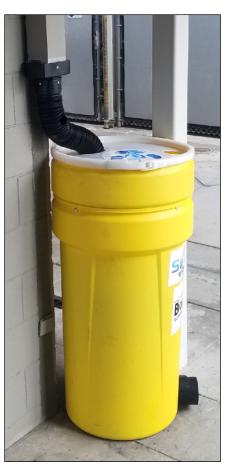
In early 2019, Downspout treatment boxes, utilizing **BiocharPEAT**<sup>TM</sup> where installed in limited locations to see how well it worked for the site in both 55 Gallon Drums and in 275 Gallon IBC Totes.

Even though there were three individual exceedences for copper in 2019-2020, Zinc showed great reductions but still not passing they upgraded the downspout boxes to larger 275 & 550 Gallon Treatment Tanks at all the downspouts plus one 5000 gallon treatment box with clarifier.

So how well has it worked? In the first half of 2021, the average is running below NALs for both Copper or Zinc.
