CUSTOM TANK

Case Study 2021

Pure Rain™ STORMWATER TREATMENT FILTRATION SYSTEMS

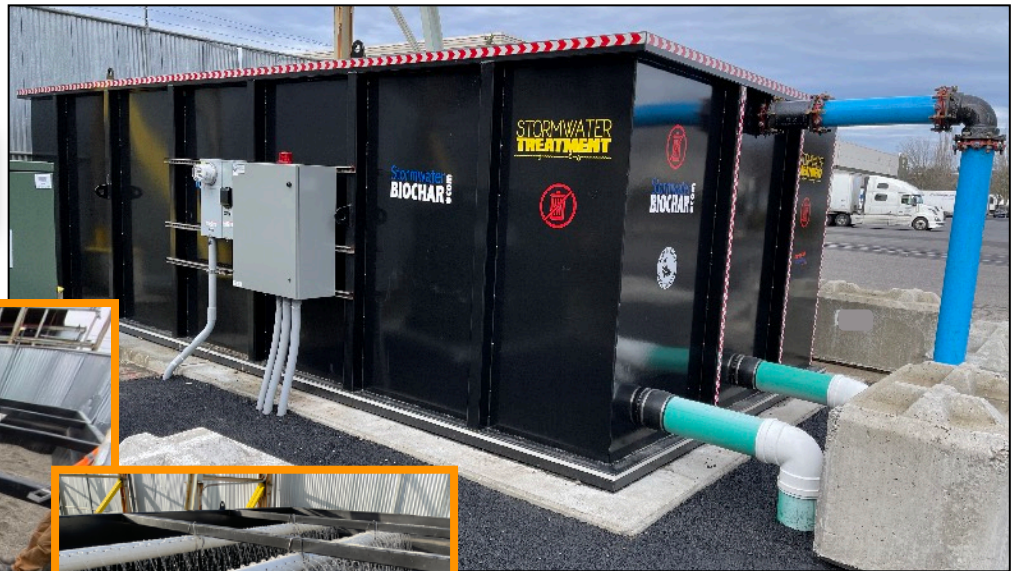
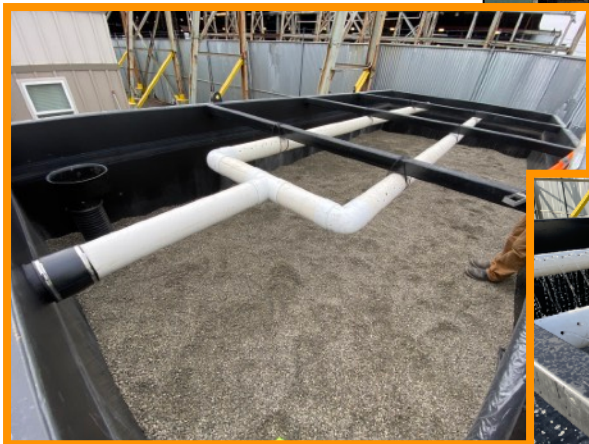
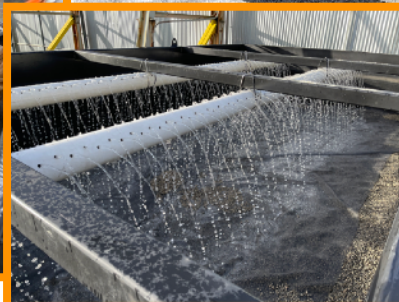
After evaluating proposals from three companies to treat the combined stormwater, the choice was to utilize **BiocharPEAT™** in a 350 GPM pump station with a 12' x 22' x 8' tall **Pure Rain™ CUSTOM TANK** built locally. The **Pure Rain™ CUSTOM TANK** includes 25 cubic yards of **BiocharPEAT™** treatment.

An existing catch basin had a weir added to it with a pipe on the influent side put into it to gravity feed the water to a new vault. In the vault, two 350 GPM pumps were installed to pump the water to the **Pure Rain™ CUSTOM TANK**. The stormwater then gravity flows through the **Pure Rain™ CUSTOM TANK** and back to the discharge side of the catch basin with the weir and leaves the site to the river.
