# CASE STUDY

**CUSTOM  
TANK**

Vancouver Washington

## Multi-Tenant Industrial Park

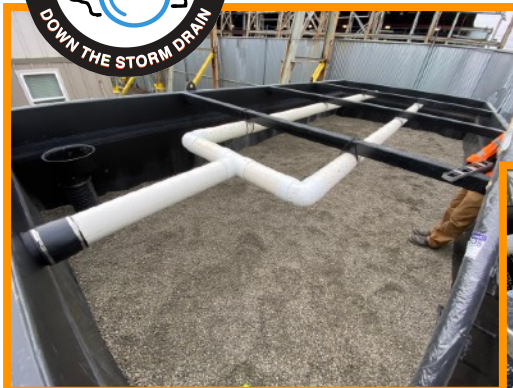
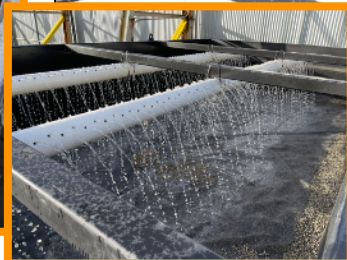
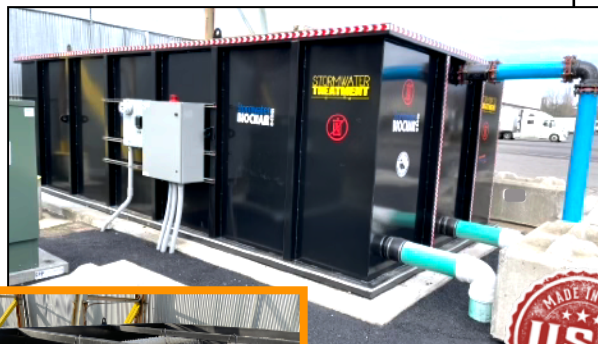
An existing catch basin had a weir added to it with a pipe on the influent side put into it to gravity feed the water to a new vault. In the vault, two 350 GPM pumps were installed to pump the water to the **CUSTOM TANK**. The stormwater then gravity flows through the **CUSTOM TANK** and back to the discharge side of the catch basin with the weir and leaves the site to the river.

After evaluating proposals from three companies to treat the combined stormwater, the choice was to utilize **BiocharPEAT™** in a 350 GPM pump station with a 12' x 22' x 8' tall **CUSTOM TANK** built locally. The **CUSTOM TANK** includes 25 cubic yards of **BiocharPEAT™** treatment.
