CASE STUDY

Portland Oregon Winning Combination Automotive Transporter Company

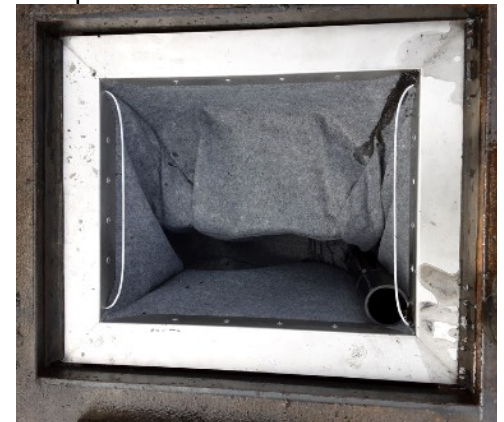
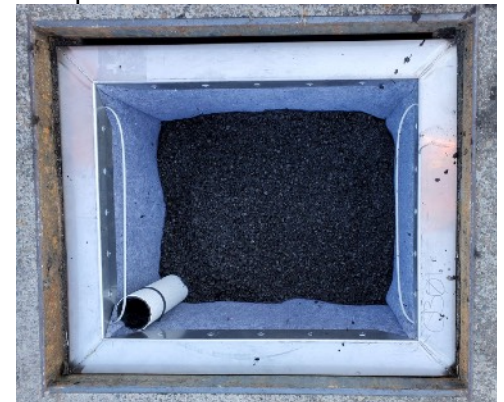
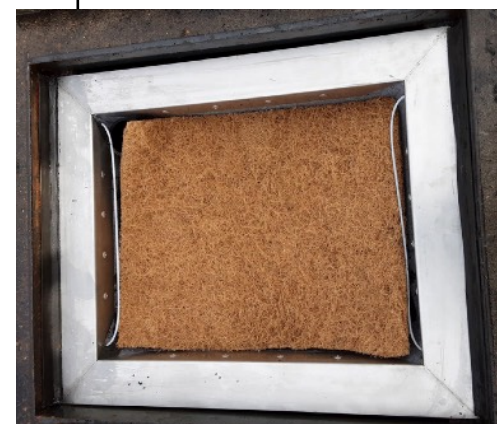
Below are the test results for testing done before replacing of the competitors product and after the new BMPs including **BiocharBASIC™** was utilized.

Test Date	Copper µg/L	Lead µg/L	Zinc µg/L	Iron µg/L	TSS mg/L
2/16/17	4.8	1.1	501	NT	17.2
4/24/17	4	0	70	NT	0
11/13/17	7	1.4	174	441	22
12/19/17	19.8	6.7	269	2440	142
12/20/18	5.6	0.9	85.5	NT	34
3/13/19	15.9	5.2	116	2050	8.96
3/28/19	10.2	5.2	47.5	653	32.5
Average Before Treatment	9.61	2.93	180	1396	36.67
Benchmark Before 2021	20	40	120	1000	100
10/10/20	5.8	0	66.4	101	8
11/5/20	5	0	52.7	181	6
3/19/21	5.1	0.733	44.07	417.7	5
4/5/21	4.2	0.367	33.13	131.7	0
11/17/21	3.6	0.233	31.07	108.5	1.33
12/1/21	5.1	0.267	34.13	169.3	0
Average After Treatment	4.8	0.27	43.6	185	3.39
	Copper	Lead	Zinc	Iron	TSS
Average Reduction	50%	90%	74%	84%	99.9%
